Road Safety Assessment US 70, MP 294 to 298

ADOT Safford District San Carlos Apache Tribe

September 15-17, 2009

**Arizona Road Safety Assessment Program
ADOT Traffic HES Section
1615 W. Jackson Street, Mail Drop 065R
Phoenix, AZ 85007-3217
602-712-7601**

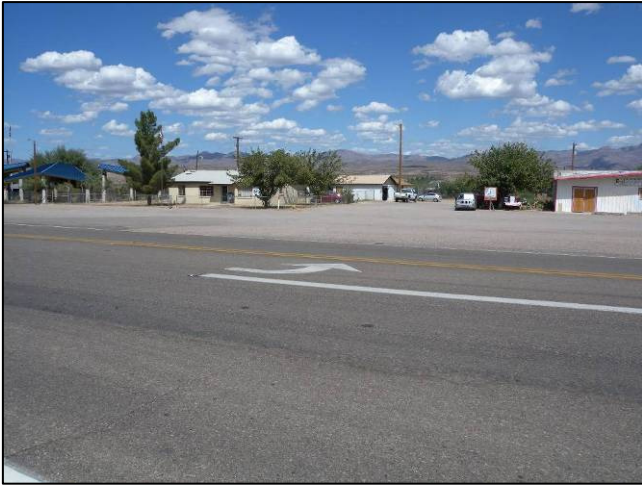
Multiple undefined entrances along US 70 at the Mt. Turnbull Market, the post office, and the vendor area create vehicular and pedestrian conflicts since there are no defined areas for entering and exiting vehicles and for pedestrians using the paved pathway that runs east and west of this area. It is recommended that curb be installed on the north side of US 70 to define and limit access points from the east side of the Market to the Bylas Rest Area. The east access at the Market is 70 feet in width. Vehicles were observed making acute angle turn maneuvers in and out of this access. Consideration should be given to closing the east access to the Market. If this is not an option, this 70-foot wide opening should be narrowed to a standard 40-foot width driveway. Another option is to make this access an entrance only.

Undefined access at post office/vendor area

SAFETY ISSUE	COUNTERMEASURES FOR CONSIDERATION
Mt. Turnbull Market Area	<ul style="list-style-type: none"> • Install curb on north side of US 70 from east side of Market to Bylas Rest Area • The east access to the Market should be closed. The standard width of a commercial driveway is only 40 feet. If not closed, consider making this access an entrance only • Install a pedestrian path or sidewalk through the Market/Post Office circulation areas to connect existing paved path and to better define the pedestrian way. This path should be concrete to distinguish it from the paved parking/circulation area • The proposed incubator internal circulation should be addressed for both vehicles and pedestrians. There may be a need for a defined pedestrian path between the incubator amphitheater and the Mt. Turnbull Market • If the Market east driveway is used for access to the new offices/post office development, the access width should be narrowed to no more than 40 feet, it should be entrance only, and the existing westbound right-turn lane should be extended further to the east to provide adequate deceleration distance • Re-align the intersection of the Market driveway and Centerpoint Entrance to remove the through lane offset

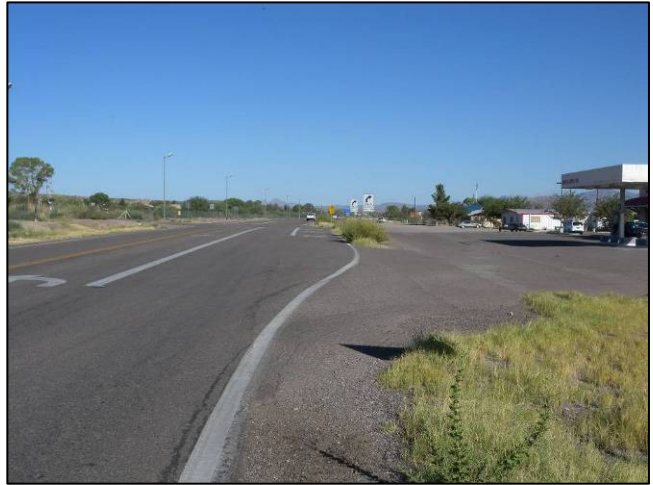
70-foot opening at Mt. Turnbull Market, located at the right-turn lane taper

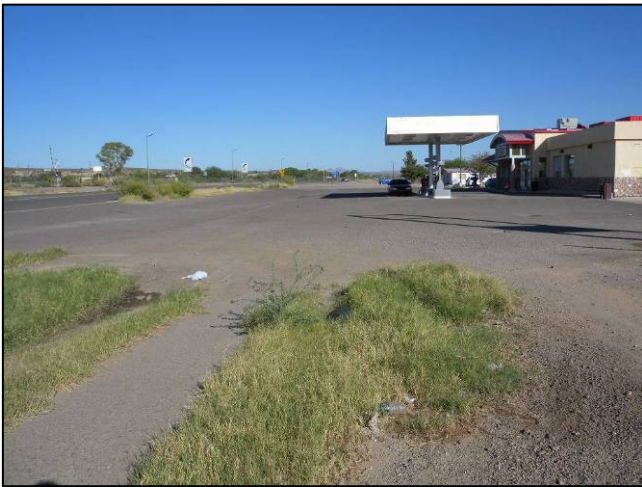
The 3.5-mile long paved pathway on the north side of US 70 is a nice safety feature for pedestrians and bicyclists. However, the pathway is discontinuous at the busiest activity center, the Mt. Turnbull Market/Post Office area. Pedestrians in this area have no defined pathway, and are in conflict with vehicles entering, exiting, and parking at the Market and Post Office. It is recommended that a pedestrian path or sidewalk be installed through the Market/Post Office circulation areas to connect the existing paved path and to better define the pedestrian way. This path should be concrete to distinguish it from the paved parking/circulation area.

Paved pathway east of the Mt. Turnbull Market ends at the Market area

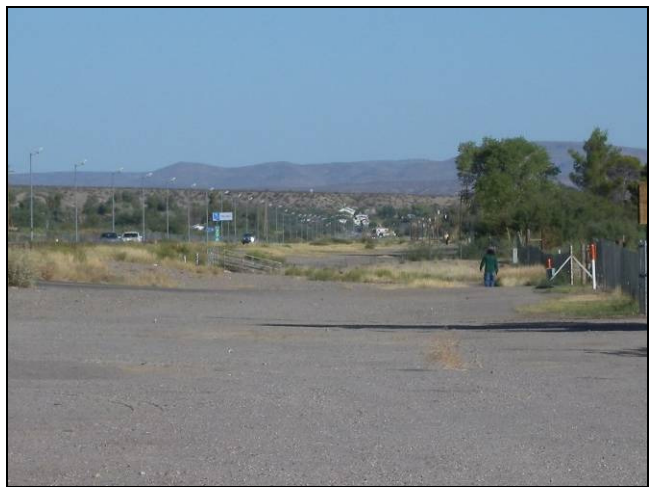
Paved pathway west of the post office ends at the post office area

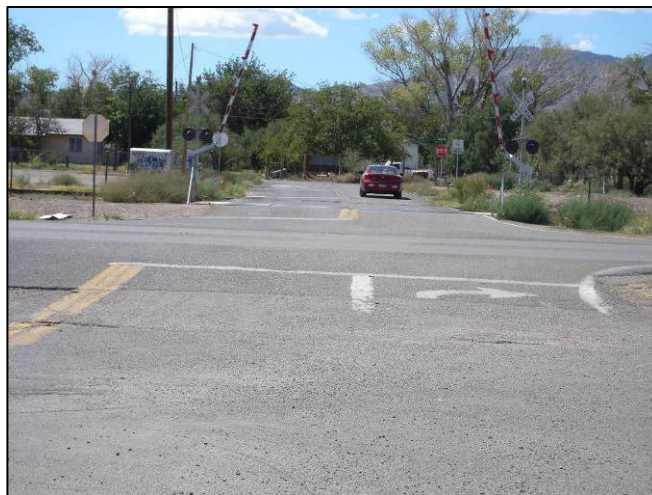
The side road through lanes are offset and do not line up at the intersection of the Market driveway and Centerpoint Entrance. The offset lanes can lead to drivers crossing US 70 and inadvertently encroaching on the oncoming lane, creating a possible head-on or sideswipe crash scenario. The offset is approximately 12 feet. It is recommended that this intersection be re-aligned to remove the offset. This could be partially accomplished by re-striping the approach lanes on the Market side of the intersection so that the far right lane is a shared right and through lane.

Offset through lanes at Market driveway intersection

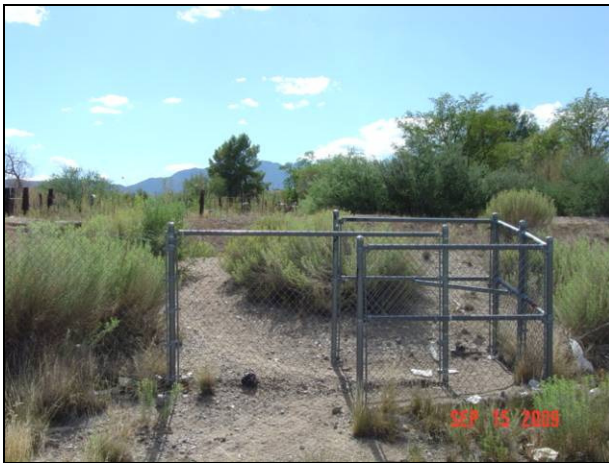
There are numerous, poorly-located pedestrian passes which encourage and allow crossings at many locations along US 70. A study should be conducted to evaluate the origins and destinations, where and how many pedestrians are crossing US 70, and to determine if any pedestrian gates can be eliminated to reduce the number of pedestrian crossing locations. ADOT’s Planning Assistance for Rural Areas (PARA) funds can be used for this type of study. PARA will fund 100% of the study costs, but the funds are distributed on a competitive basis.

Pedestrian gate at ROW fence

Consider installing ADA-compliant pedestrian gates, and/or provide some type of transit service (golf cart, van) to assist the disabled and elderly in crossing US 70, especially at cattle guard locations. The large cracks on the paved pathway should be repaired to eliminate tripping issues. Long term, if curbing is installed on the south side of US 70, consideration should be given to constructing a sidewalk on the south side of US 70.

Pedestrians	<ul style="list-style-type: none"> • An evaluation of the appropriateness of the current 50 mph speed limit should be conducted, considering additional factors such as roadside development, pedestrian activity, and crash experience • Install additional pedestrian crossing warning signs, with flashing lights, for both eastbound and westbound directions, particularly in the Market/Post Office and Health Center areas • Consider eliminating the passing zones through Bylas (located at mileposts 294.6 to 295.5 and 296.5 to 297.6) • A study should be conducted to evaluate where and how many pedestrians are crossing US 70, and to determine if any pedestrian gates can be eliminated to reduce the number of pedestrian crossing locations (ADOT's PARA funds can be used for this type of study) • Consider installing ADA-compliant pedestrian gates, and/or provide some type of transit service (golf cart, van) to assist the disabled and elderly in crossing US 70, especially at cattle guard locations • Repair large cracks on the paved pathway • Long term, if curbing is installed on the south side of US 70, consideration should be given to constructing a paved pedestrian path on south side of US 70

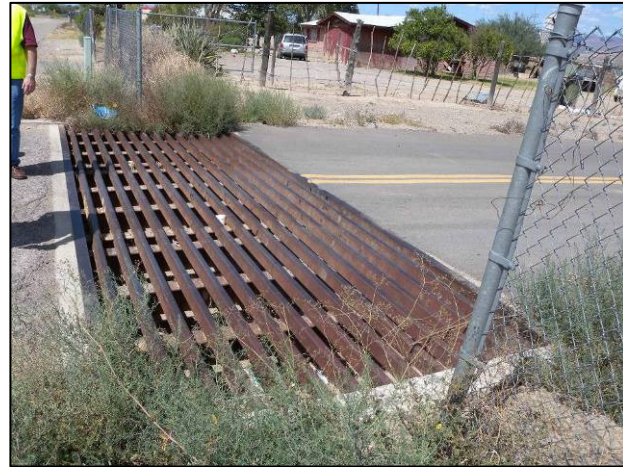
Cattle guard near side street intersection with US 70

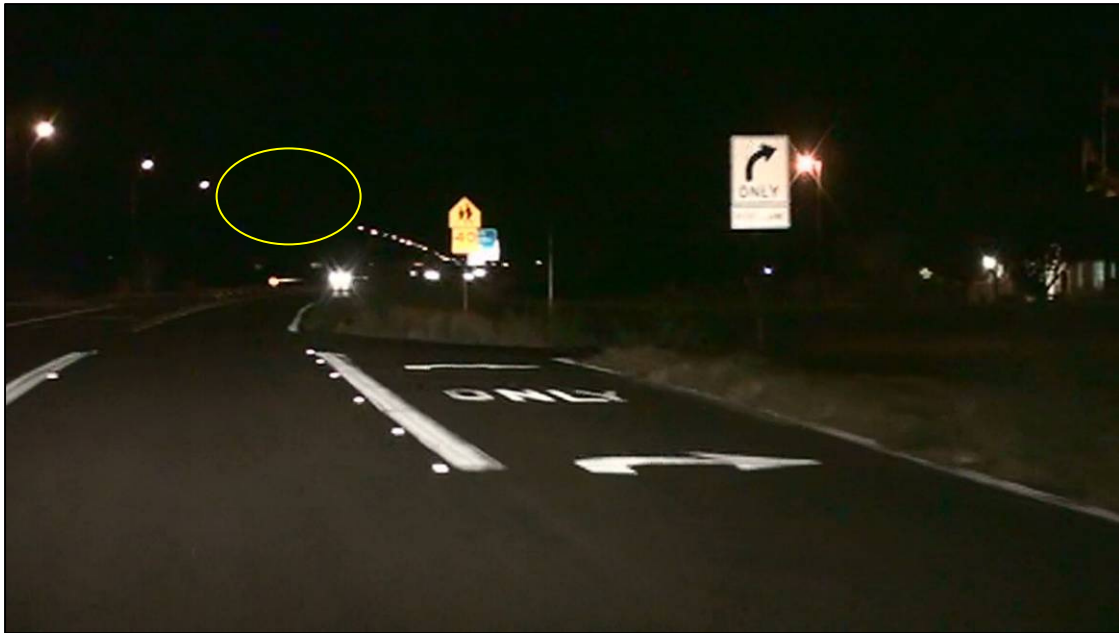
Street lighting exists along the south side of US 70. In addition to providing illumination on US 70, the street lights also help illuminate the paved pathway on the north side of US 70. However, some of the lights are not working. Just west of the rest area, 4 consecutive lights are not working, creating a dark section along the paved pathway and US 70, making it difficult for motorists to see pedestrians crossing the road. There are 3 lights out between mileposts 294 and 295, and 1 light out between mileposts 296 and 297. These malfunctioning lights should be repaired. Also, it would be helpful if the local police could inform ADOT of lights not working by providing the pole number of the malfunctioning light.

Gap in lighting created by malfunctioning street lights near the rest area

Lighting	<ul style="list-style-type: none"> • Repair malfunctioning street lights: 4 consecutive lights just west of the rest area, 3 lights between mileposts 294 and 295, and 1 light between mileposts 296 and 297 • Request local police to inform ADOT of lights not working by providing pole number of the malfunctioning light (ADOT phone: 928-432-4912, email: tengel@azdot.gov) • Install additional lighting on the south side of US 70, particularly at the major intersections

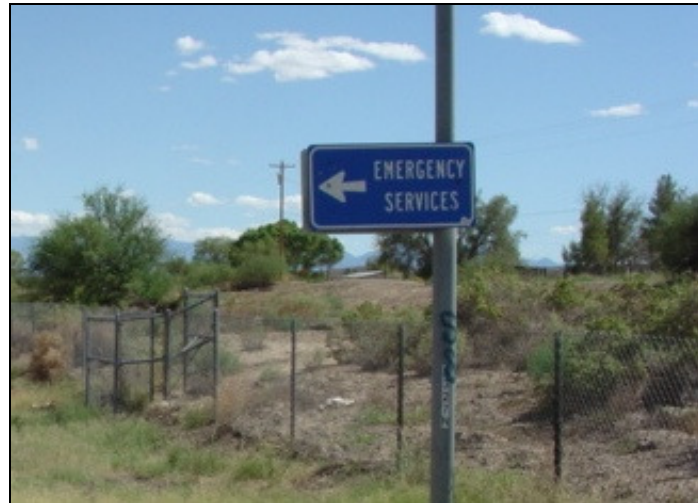
The Emergency Services sign on US 70 is small and difficult to read, and ought to specifically refer to the “Health Center”. The Police Department building is difficult to see from US 70, and there is no sign for it. In addition to the Emergency Services sign, Health Center and Police Department signs should be considered for installation in both directions along US 70.

Sign along US 70 for Health Center

SAFETY ISSUE	COUNTERMEASURES FOR CONSIDERATION
Signing	<ul style="list-style-type: none"> • Install street name signs for all side street intersections along US 70 • Install advance street name signs for the major intersections • Install large gateway signing at the eastbound and westbound entrances to the community • Install W10-2 or W10-3 rail grade crossing advance warning signs on US 70 at intersection approaches where tracks are less than 100 feet from US 70 • Consider installing Health Center and Police Department signs in both directions along US 70
Intersections	<ul style="list-style-type: none"> • Install left-turn lanes on US 70 at major intersections; if right-turn lanes are installed, they should be offset from the adjacent through lanes • Long term, a continuous two-way left-turn lane should be considered for US 70, particularly from the Health Center to the Mt. Turnbull Market • Install automatic gate systems at all major side road railroad crossings

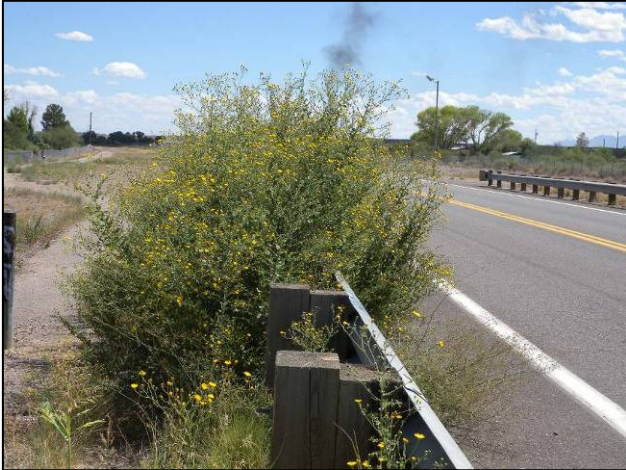
Vegetation growing along US 70 creates sight obstructions at some intersections. There are also edge drop-offs near some intersections, probably created by vehicles pulling off of US 70 in advance of the intersections. ADOT Safford District maintenance forces began addressing the vegetation growth while the RSA Team was still conducting its field reviews. The unpaved shoulders require some maintenance, and consideration should be given to using a more durable material, like millings, to withstand the repeated traffic loads.

Vegetation limits sight distance along US 70

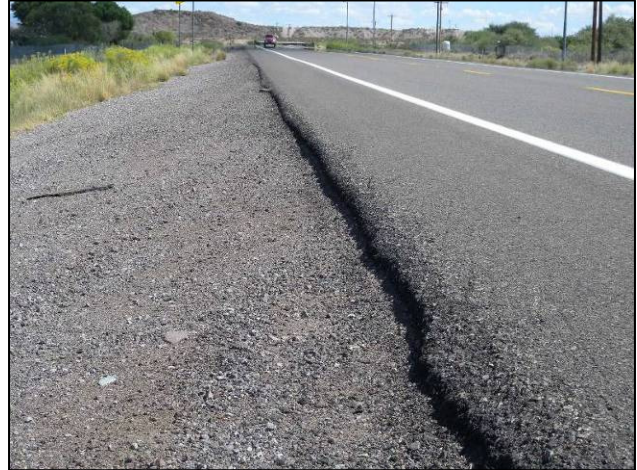
Edge drop-off along US 70
